**POVERTY POINT LIMESTONE  
QUARRY SLOPE STABILITY  
ASSESSMENT AND DESIGN  
GUIDELINES**

Submitted to: HOLCIM (US) Inc.

May 19, 2006

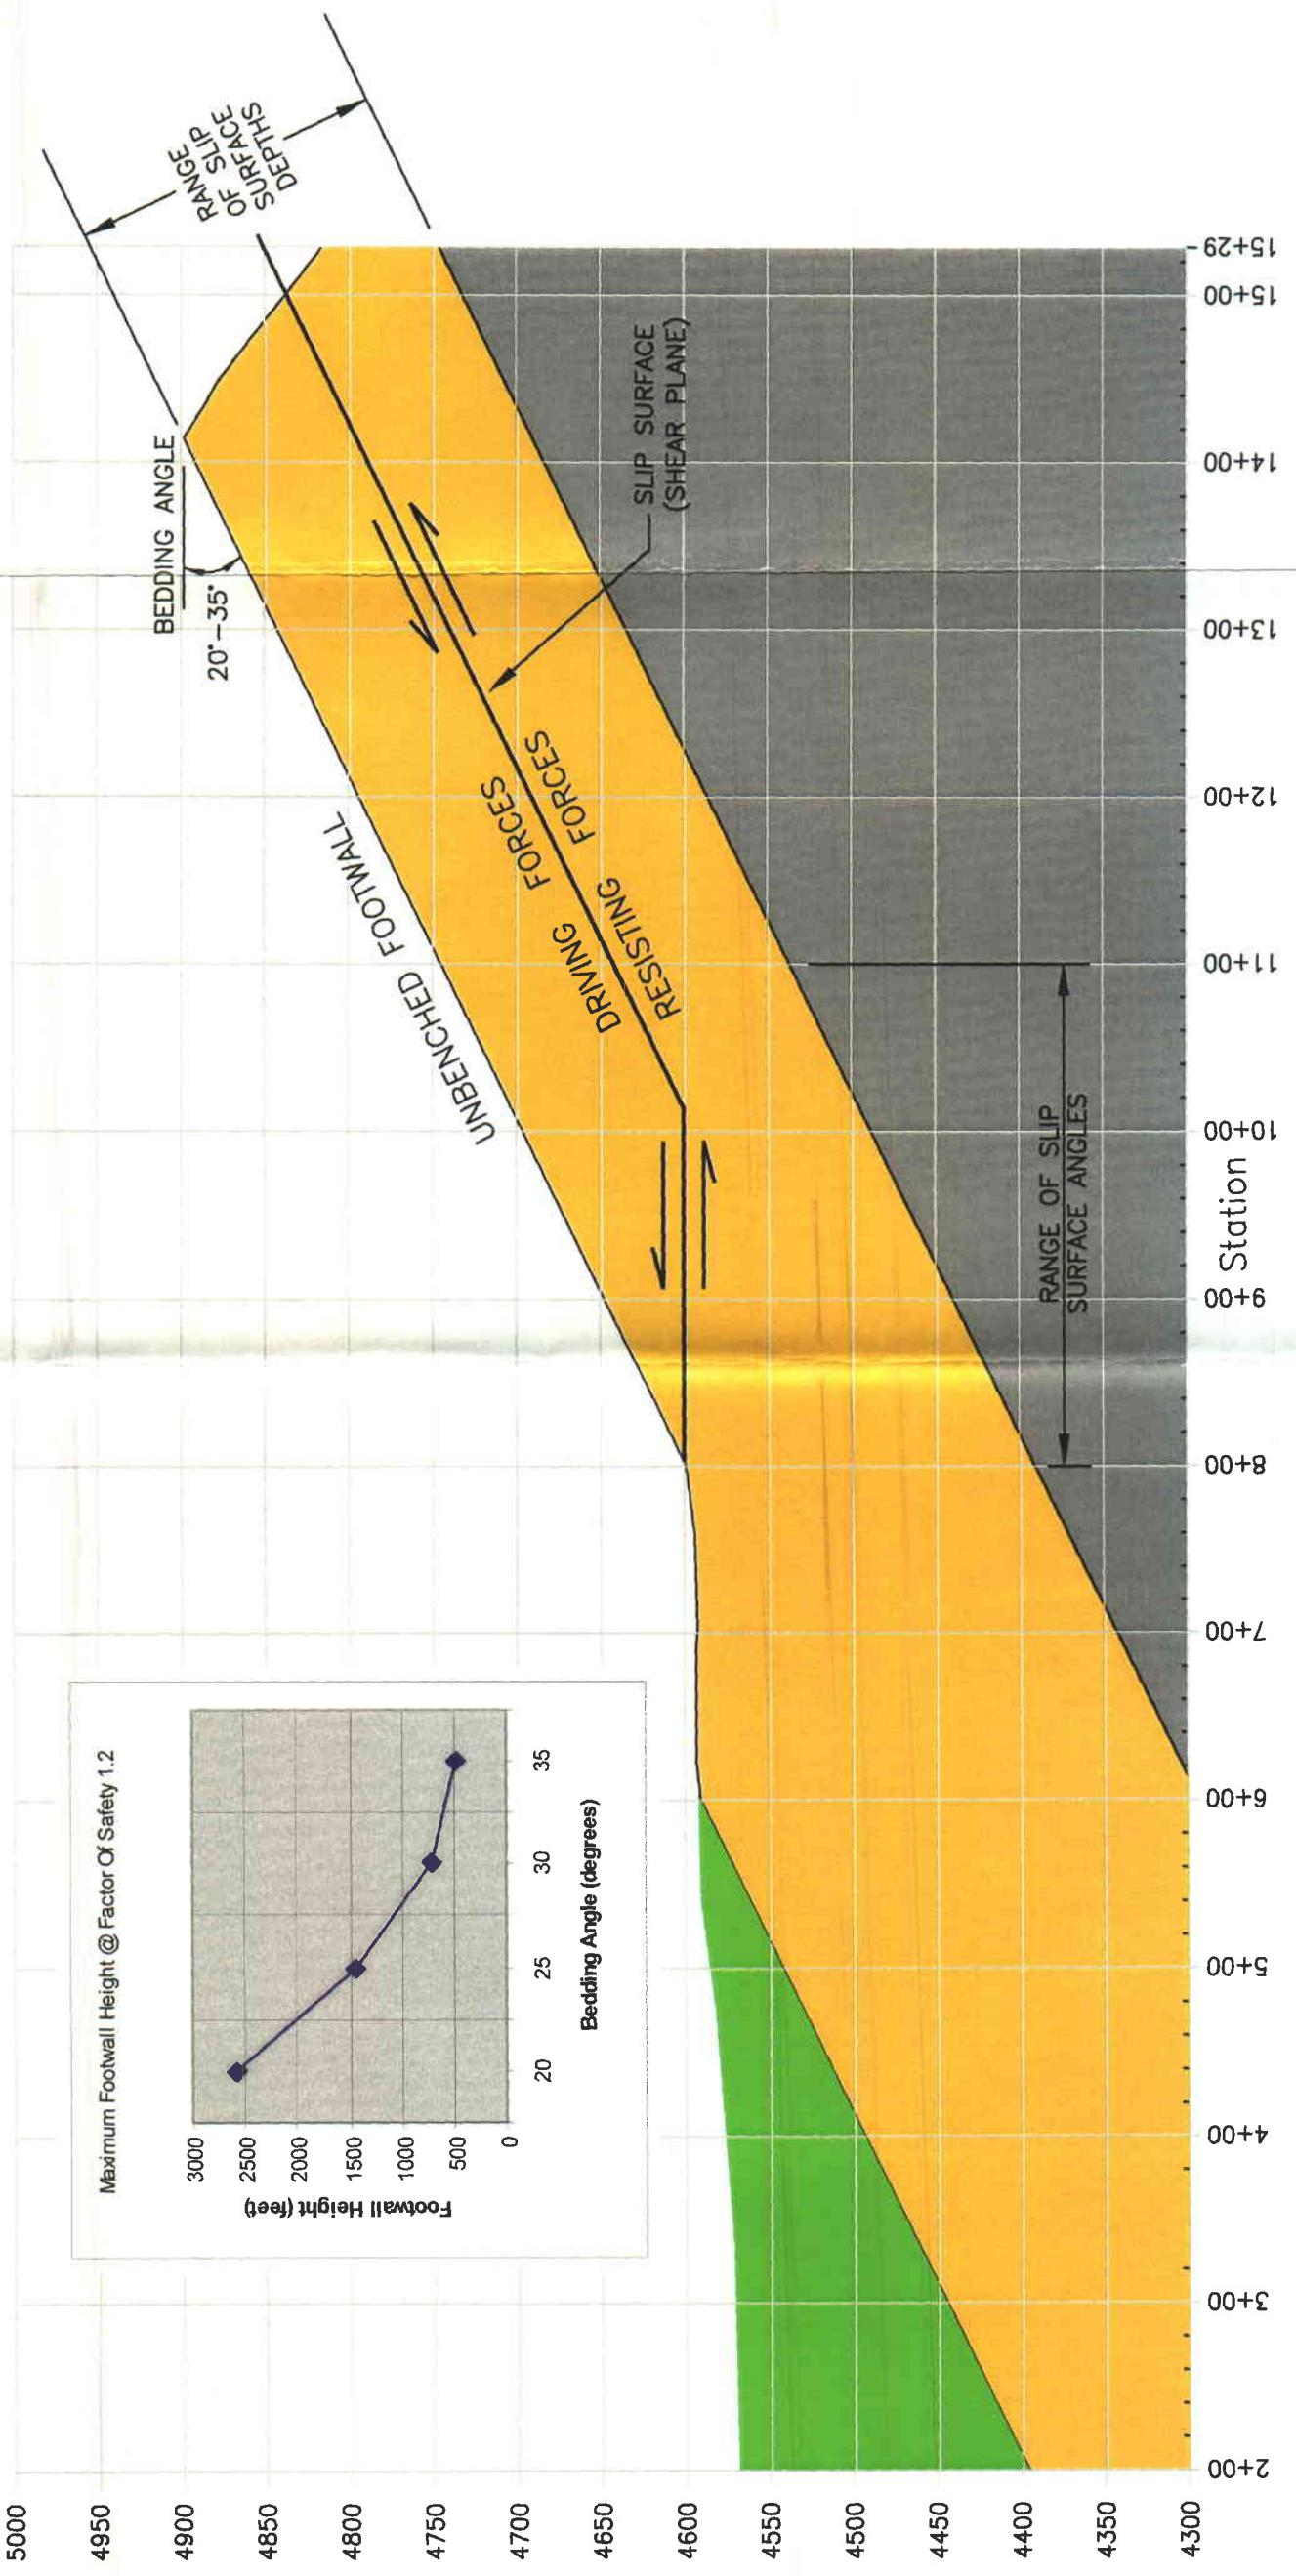
# BILINEAR SLAB FAILURE CONFIGURATION

2. Bilinear slab failure – In the absence of daylighted bedding planes, this is the primary failure mechanism considered for stability analyses of the footwall. This mechanism involves sliding parallel to bedding in combination with sliding along a secondary surface dipping out of the slope (Dawson and Barron, 1989). The secondary surface may be a persistent discontinuity surface or, if unfavourably oriented discontinuities are not present, a shear zone (slip surface) developed through the rock mass.

All of these variables were incorporated into the slope stability analysis to determine factors of safety for quarry slopes to bilinear planar failure. Slope/W software was used with fully defined slip surfaces to mimic critical bilinear slab geometries. This software uses the method of slices to calculate the limit equilibrium factor of safety, effectively comparing driving forces to resisting forces. A range of angles for slip surfaces (failure planes) through the rock mass toe were applied. An example of this modeling is shown in Figure 4.1. Slope/W plots appear as Appendix H.

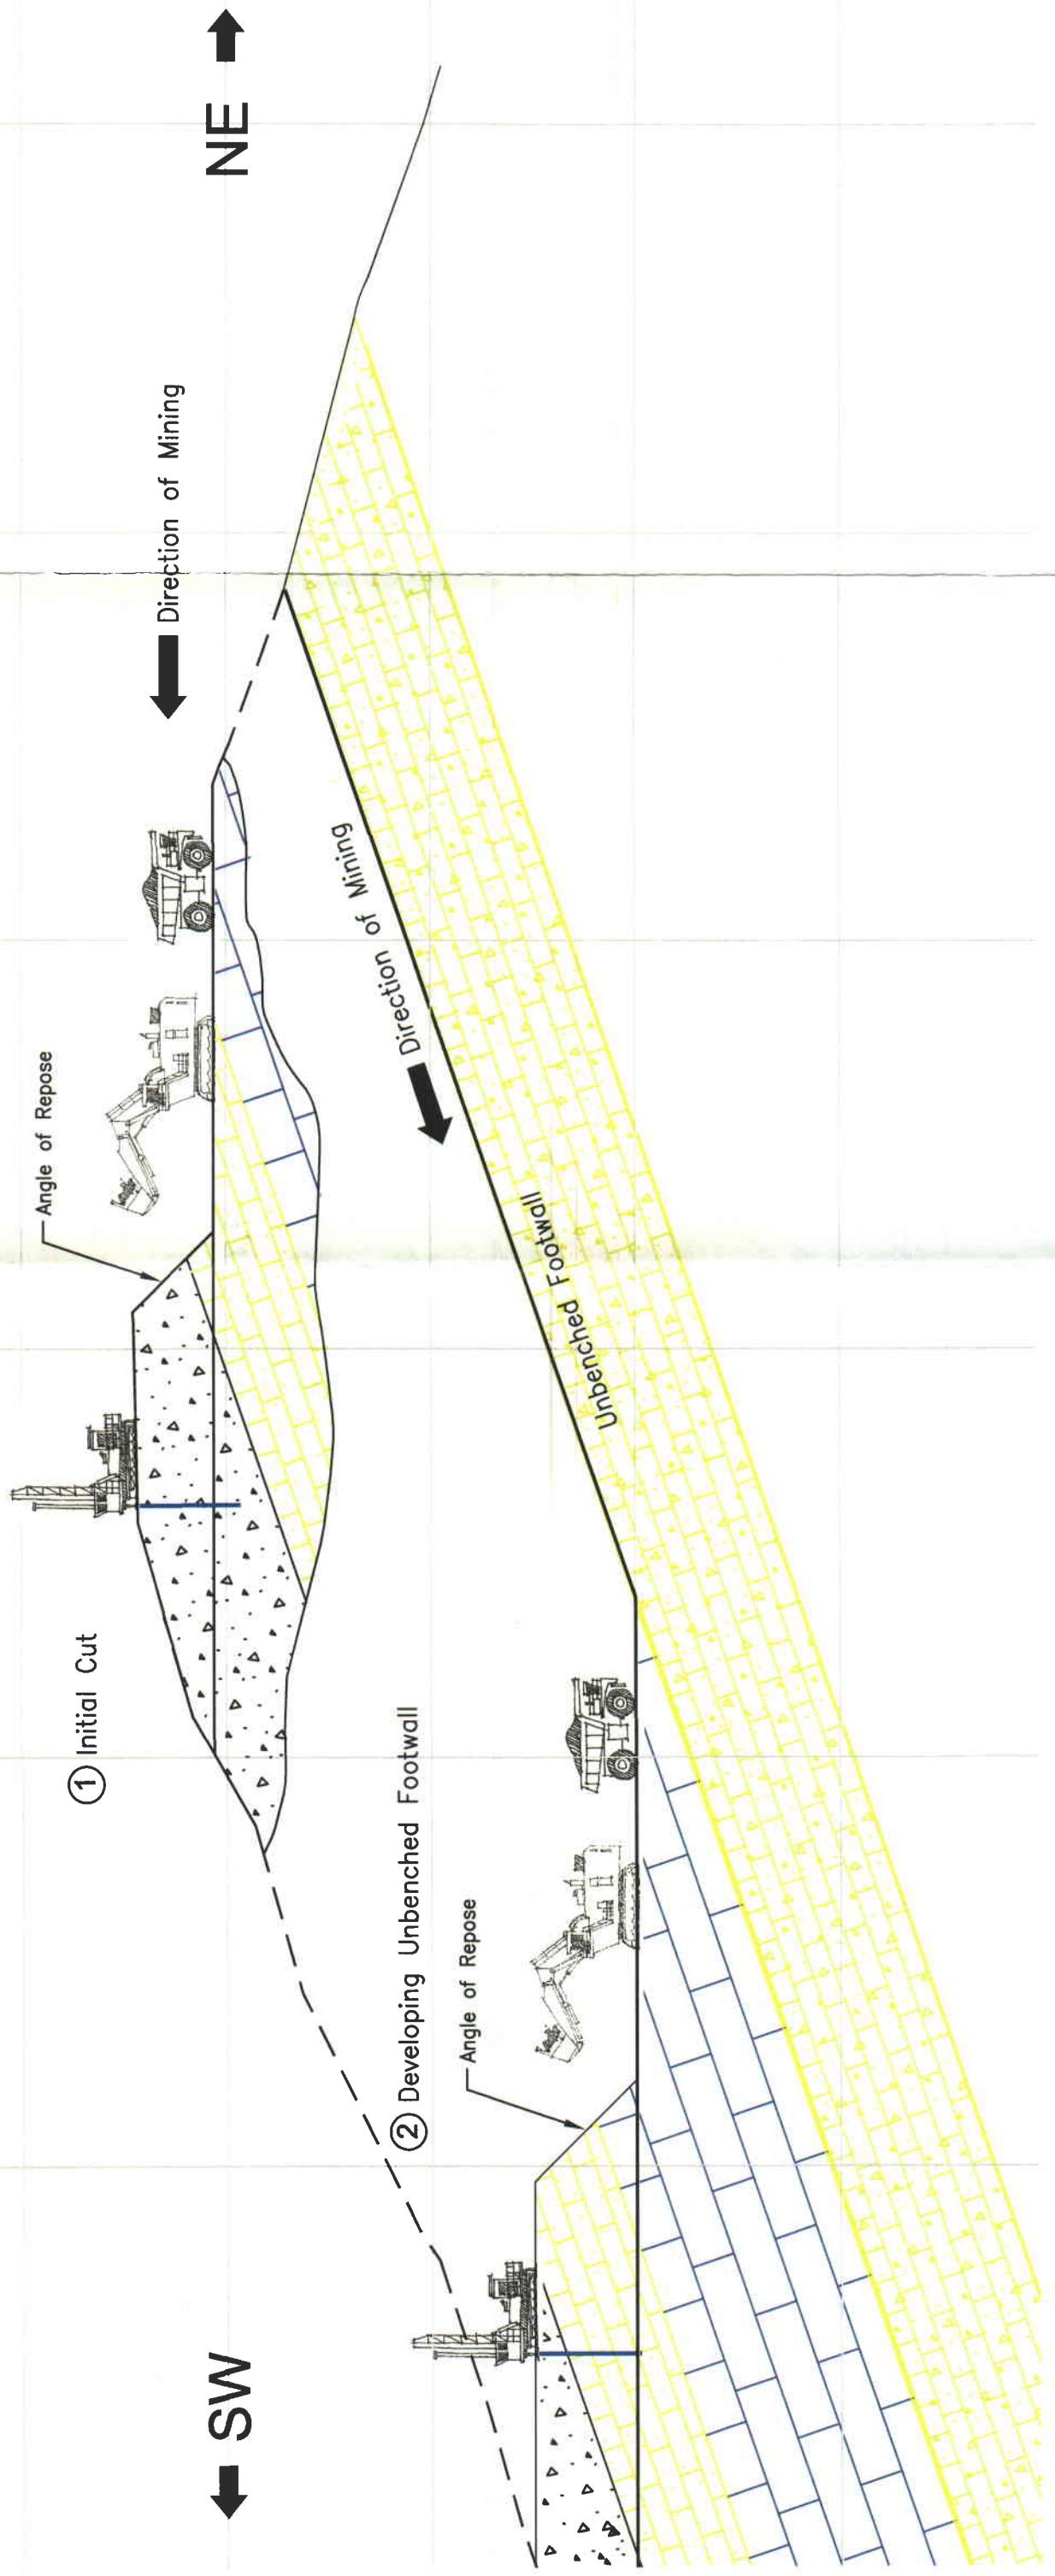
Dwg.: Fig5 Mining Method.dwg  
Fig. 5.1

Figure 5.1 shows the recommended mining method and footwall design. For footwall slopes the following preliminary design guidelines apply:

## CONCEPTUAL VIEW OF MINING METHOD

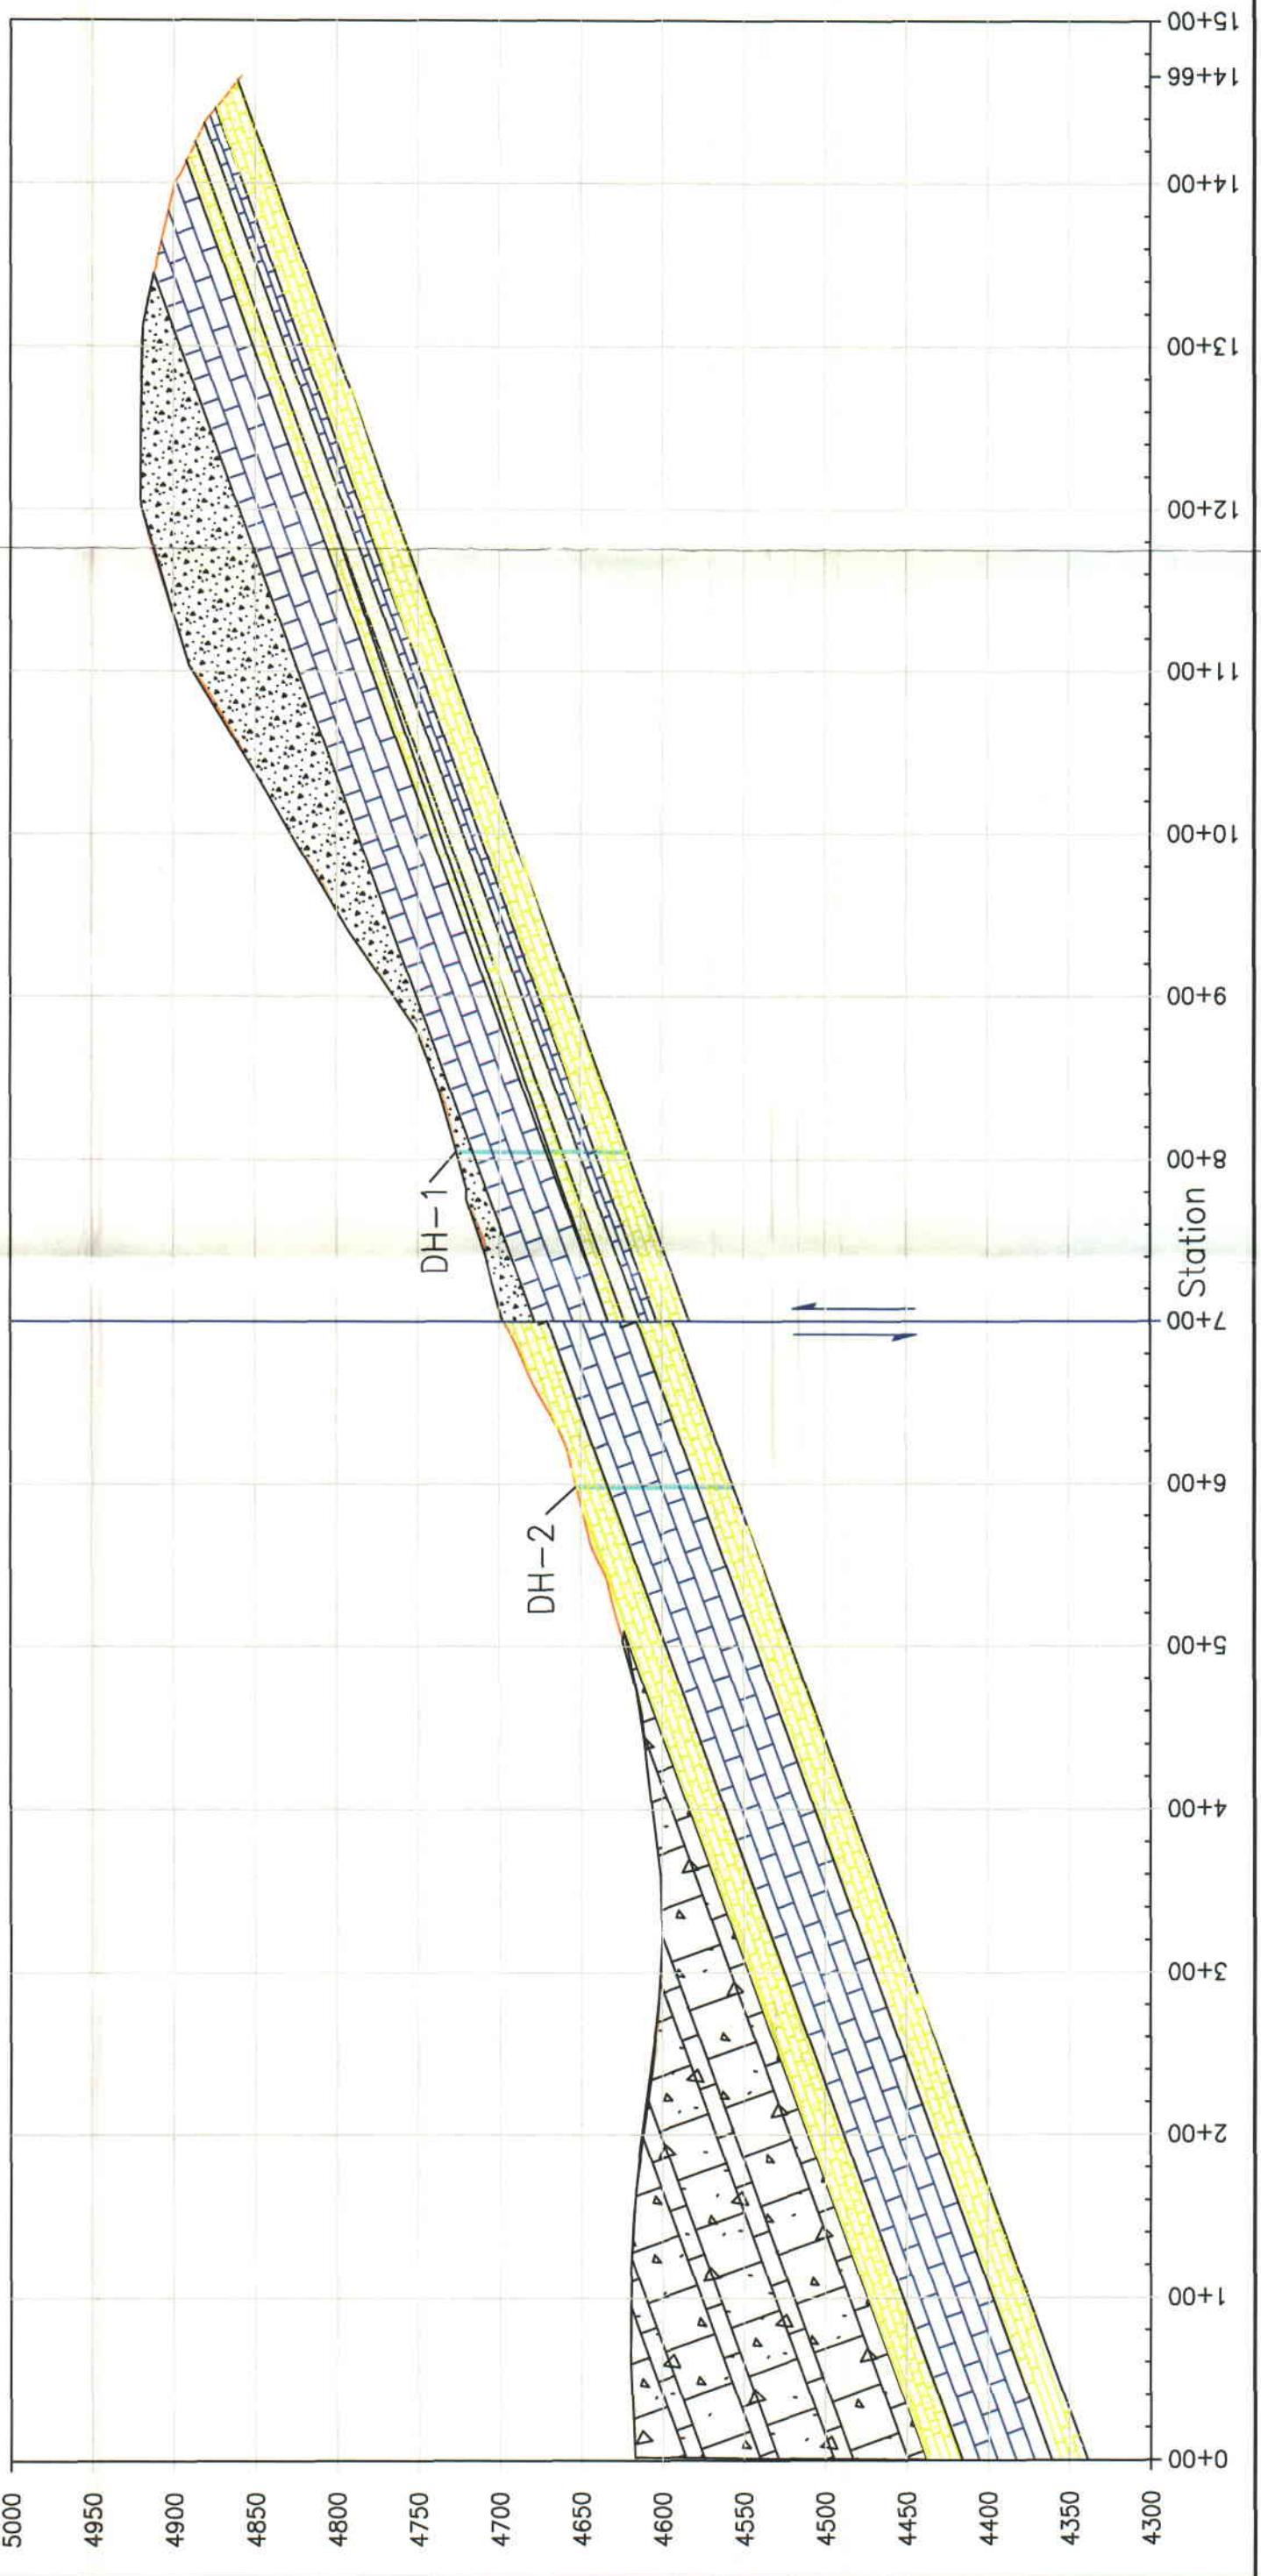
FIGURE C-1  
CROSS-SECTION A-A'SCALE: 1" = 100'  
0 50 100 200 300

LEGEND					
				ALUVIUM	
				TALUS (CONGLOMERATE)	
				HIGH PURITY Ls	
				SILICEOUS Ls	
				SANDSTONE

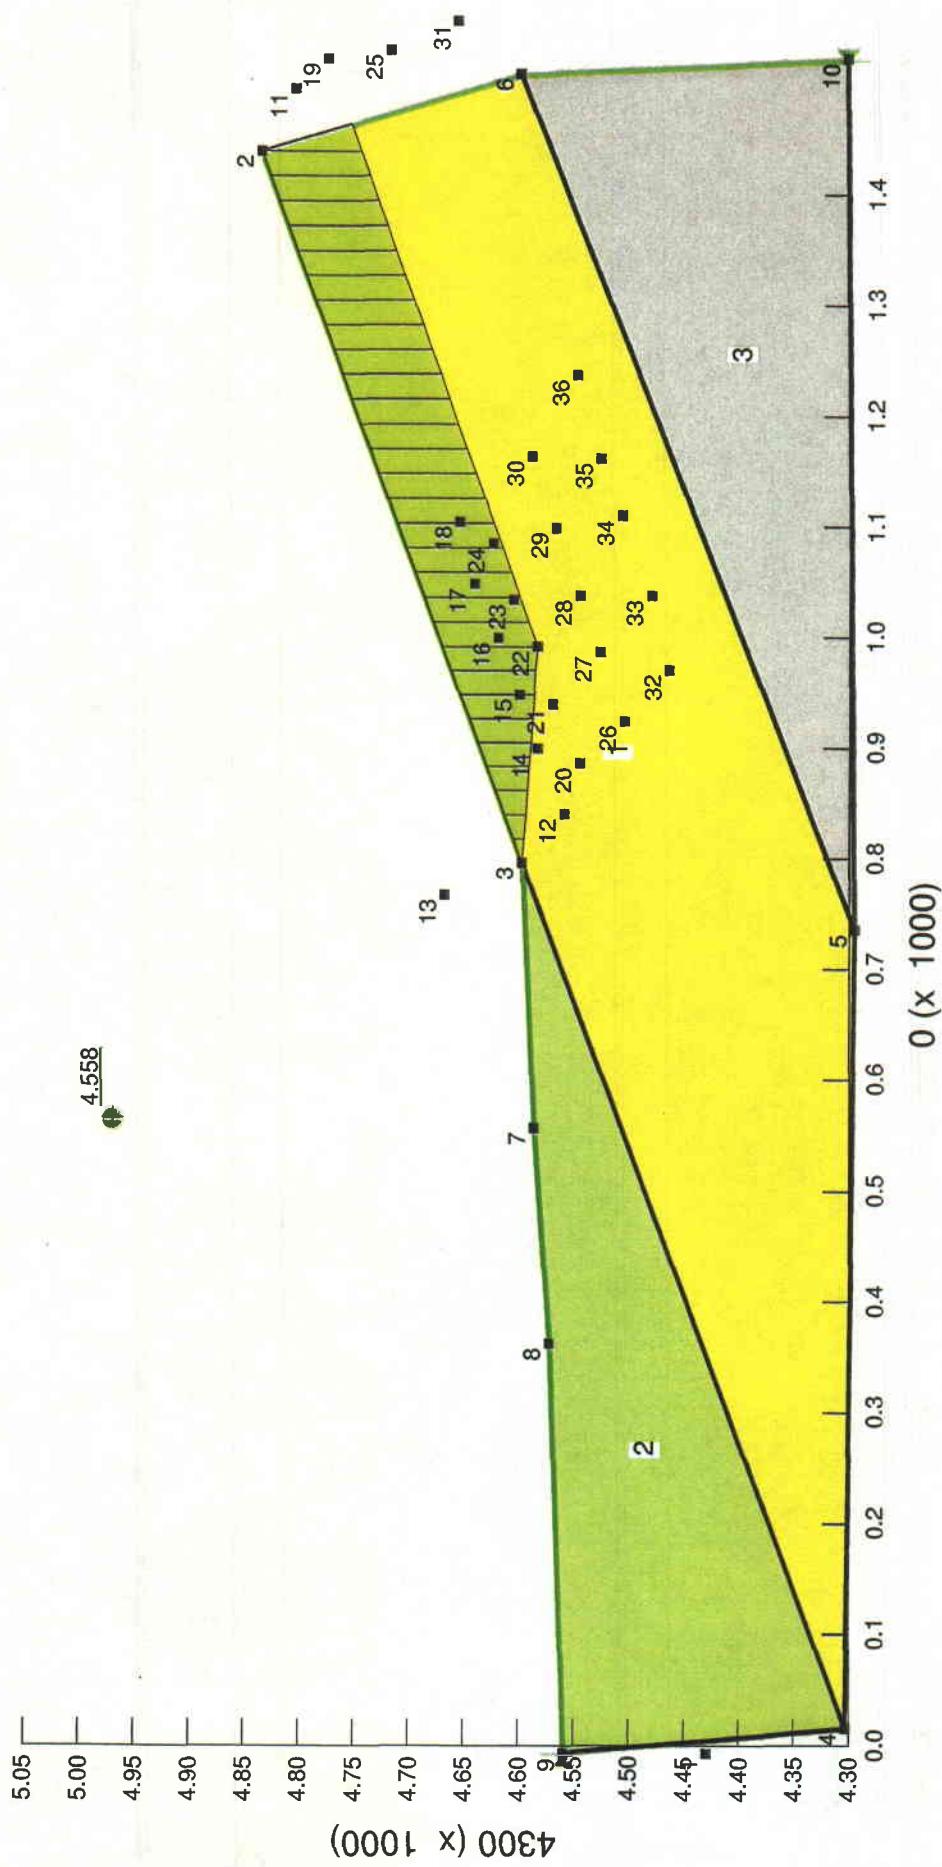
Material #: 1  
Description: Blast Disturbed Limestone  
Model: ShearNormalFn  
Wt: 100  
Strength Fn: 1  
Material #: 2  
Description: Undisturbed Limestone  
Model: ShearNormalFn  
Wt: 100  
Strength Fn: 2

Material #: 3  
Description: Alluvium  
Model: MohrCoulomb  
Wt: 100  
Cohesion: 0  
Phi: 45  
Material #: 4  
Description: Bedrock  
Model: Bedrock

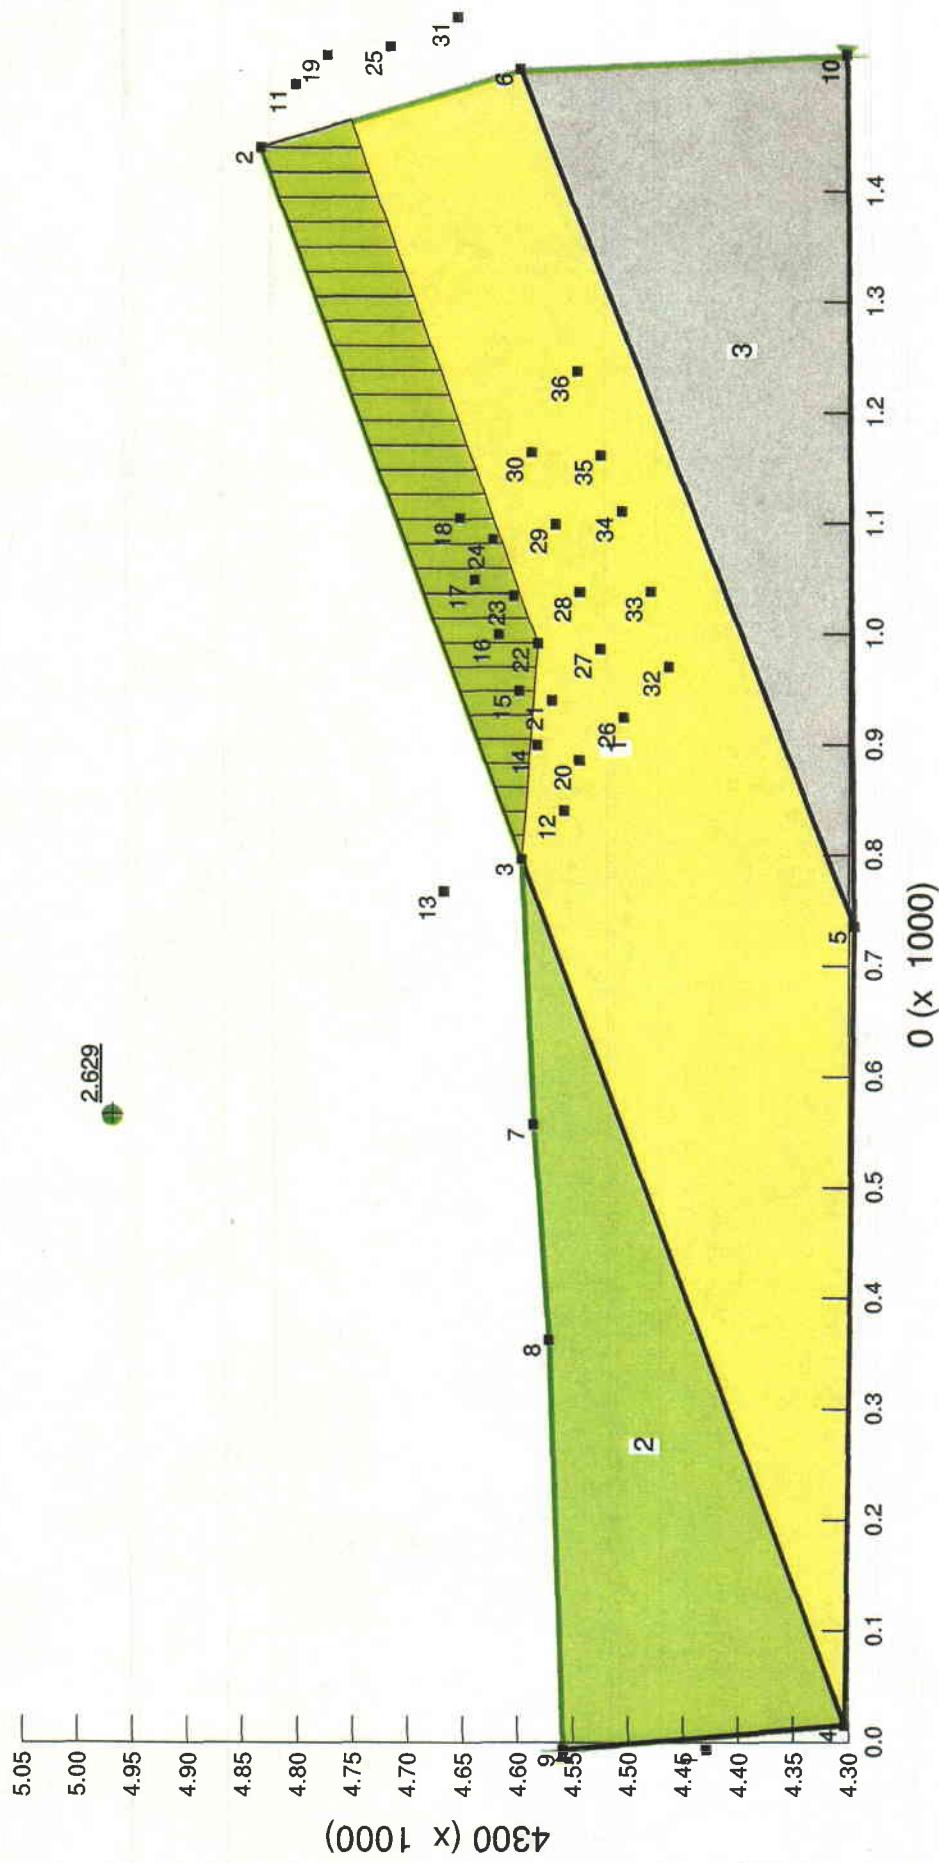
Name: 20 degrees Disturbed.gsz  
 Material #: 1  
 Description: Blast Disturbed Limestone  
 Model: ShearNormalFn  
 Wt: 100  
 Strength Fn: 1  
 Material #: 2  
 Description: Undisturbed Limestone  
 Model: ShearNormalFn  
 Wt: 100  
 Strength Fn: 2

Material #: 3  
 Description: Alluvium  
 Model: MohrCoulomb  
 Wt: 100  
 Cohesion: 0  
 Phi: 45  
 Material #: 4  
 Description: Bedrock  
 Model: Bedrock

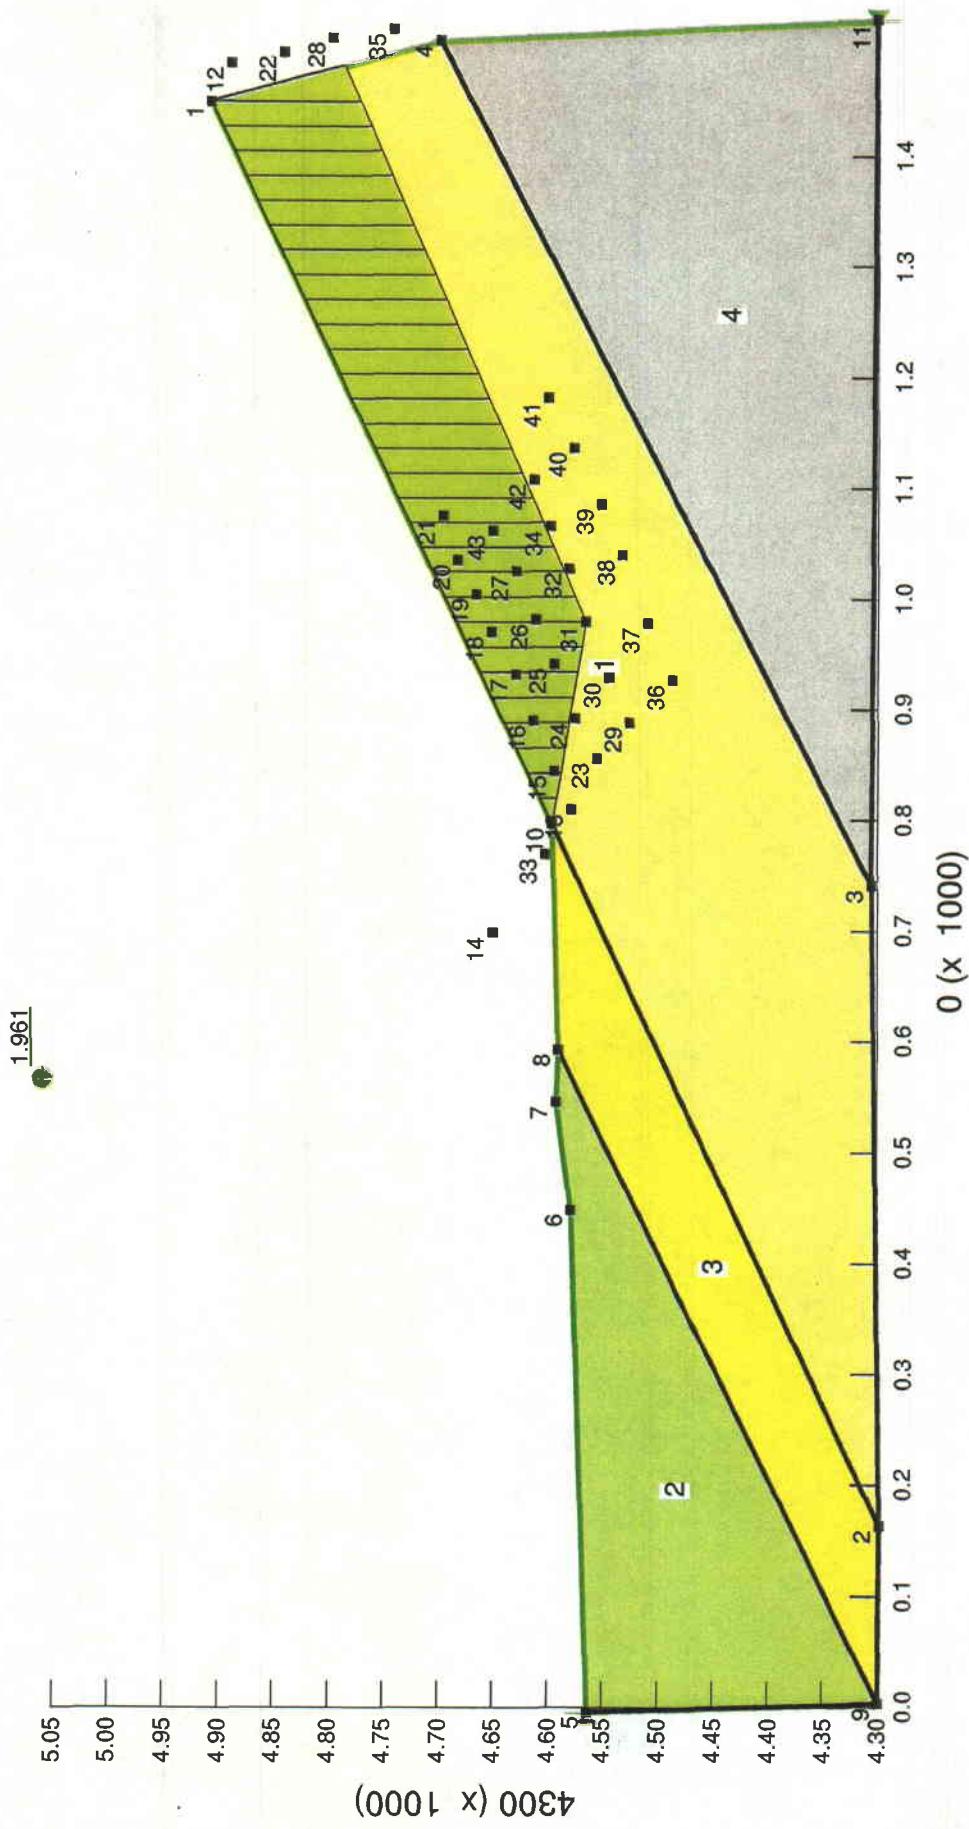
Name: 25 degrees disturbed.gsz

Material #: 1  
Description: Blast Disturbed Limestone  
Model: ShearNormalFn  
Wt: 100  
Strength Fn: 1  
Material #: 2  
Description: Undisturbed Limestone  
Model: ShearNormalFn  
Wt: 100  
Strength Fn: 2

Material #: 3  
Description: Alluvium  
Model: MohrCoulomb  
Wt: 100  
Cohesion: 0  
Phi: 45  
Material #: 4  
Description: Bedrock  
Model: Bedrock

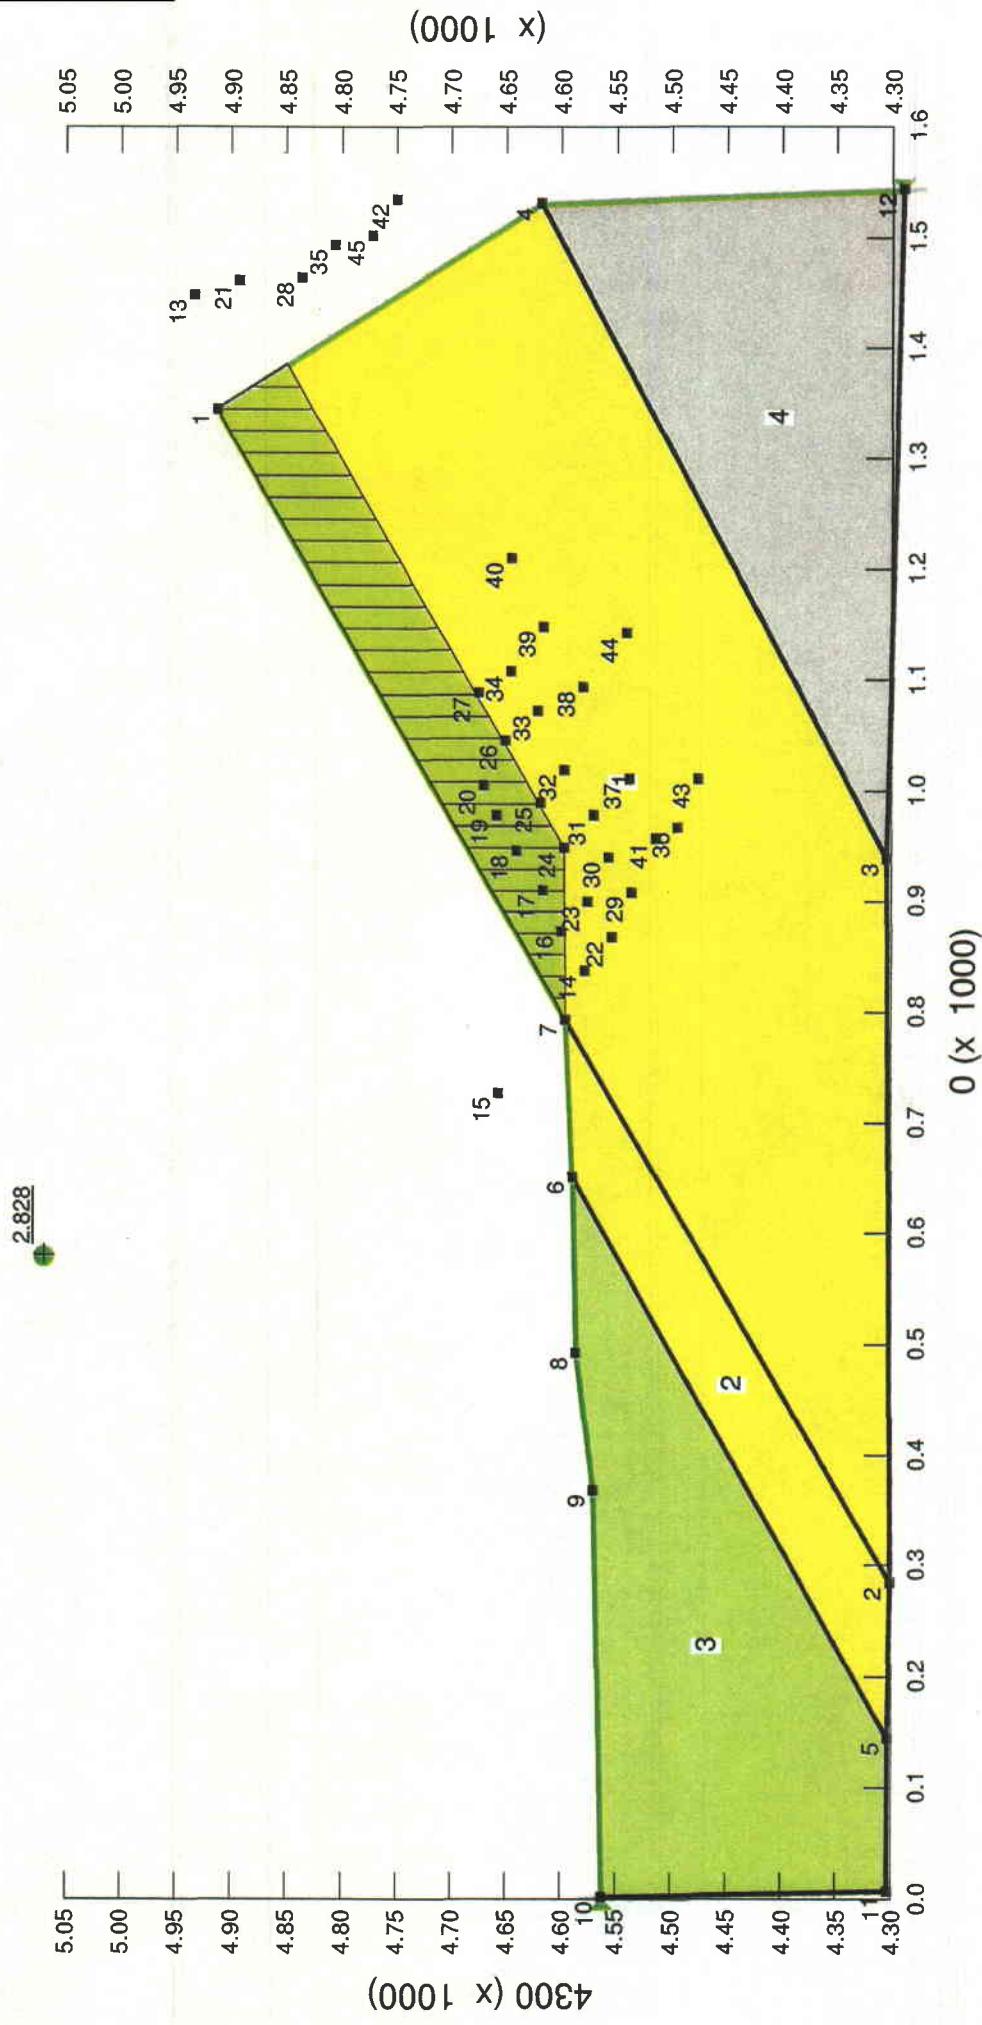
Name: 30 degrees.gsz

Material #: 1  
Description: Blast Disturbed Limestone  
Model: ShearNormalFn  
Wt: 100  
Strength Fn: 1  
Material #: 2  
Description: Undisturbed Limestone  
Model: ShearNormalFn  
Wt: 100  
Strength Fn: 2

Material #: 3  
Description: Alluvium  
Model: MohrCoulomb  
Wt: 100  
Cohesion: 0  
Phi: 45  
Material #: 4  
Description: Bedrock  
Model: Bedrock

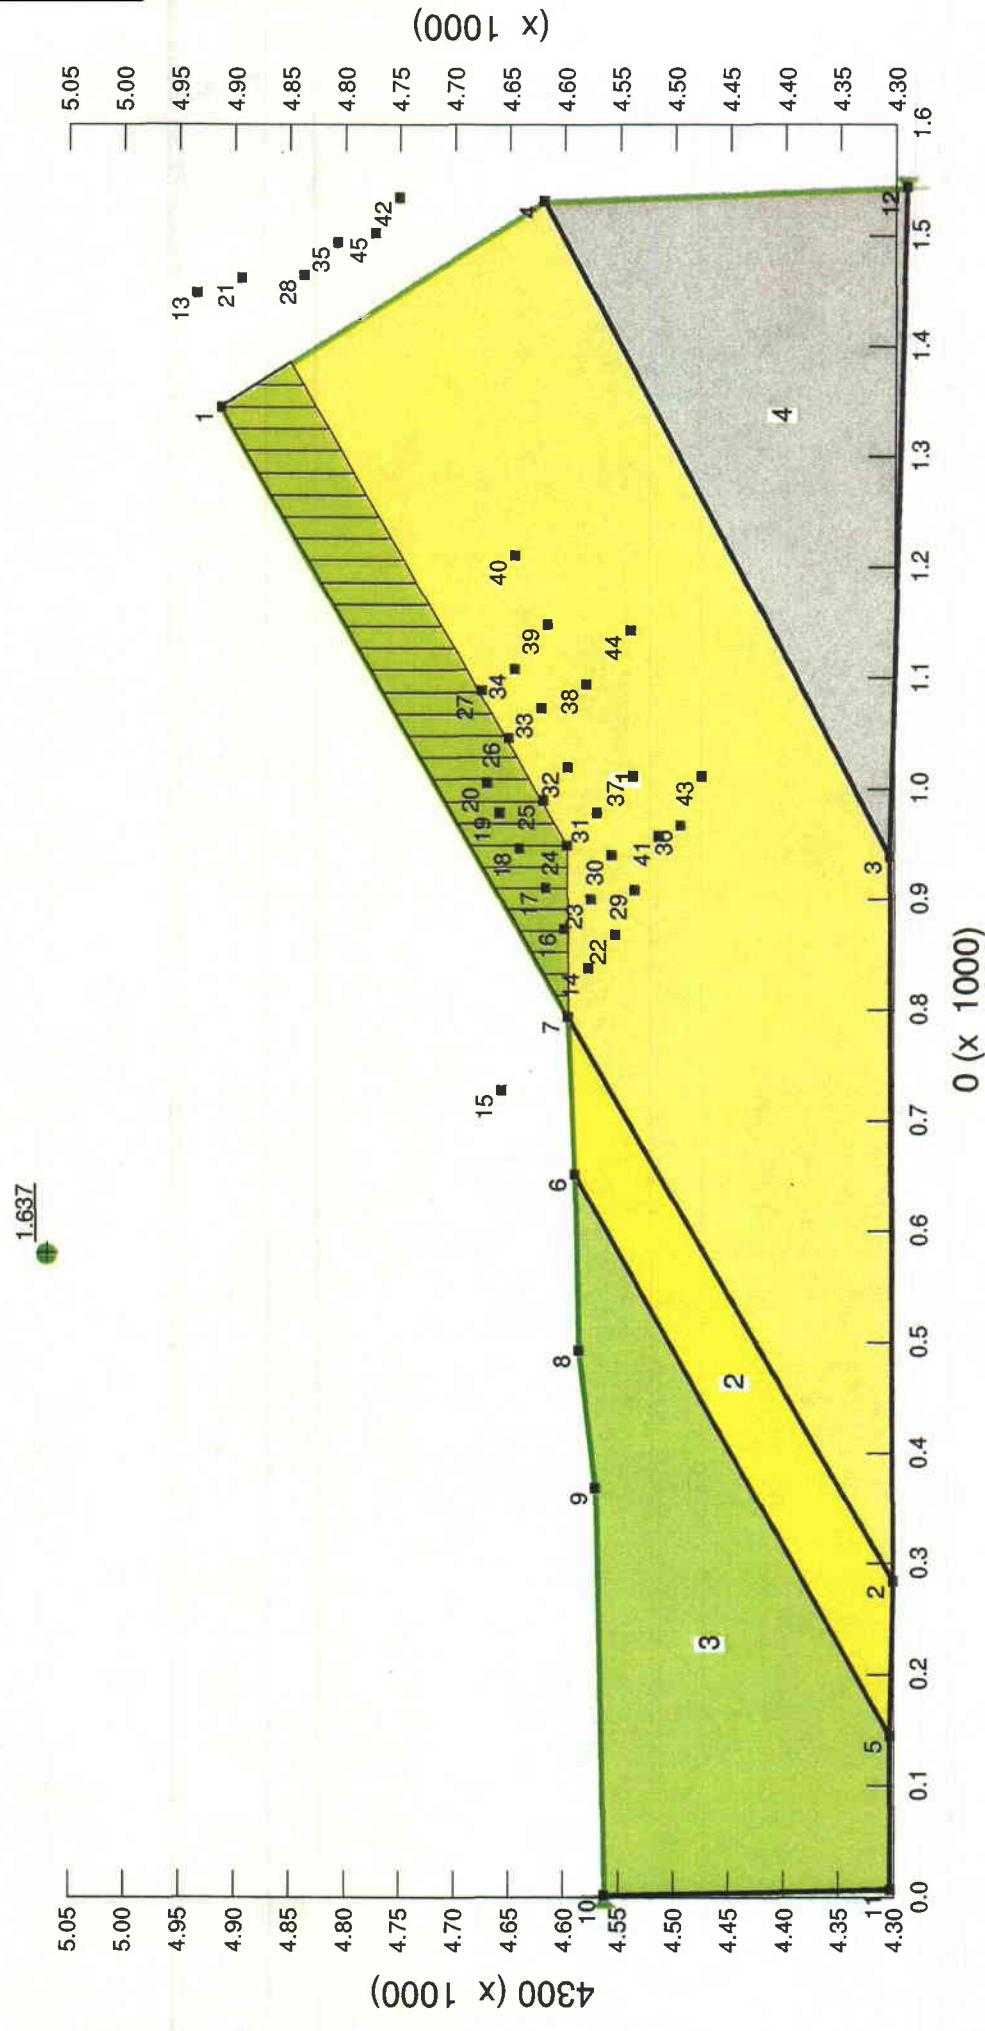
Name: 30 degrees disturbed.gsz

Material #: 1  
Description: Blast Disturbed Limestone  
Model: ShearNormalFn  
Wt: 100  
Strength Fn: 1  
Material #: 2  
Description: Undisturbed Limestone  
Model: ShearNormalFn  
Wt: 100  
Strength Fn: 2

Material #: 3  
Description: Alluvium  
Model: MohrCoulomb  
Wt: 100  
Cohesion: 0  
Phi: 45  
Material #: 4  
Description: Bedrock  
Model: Bedrock

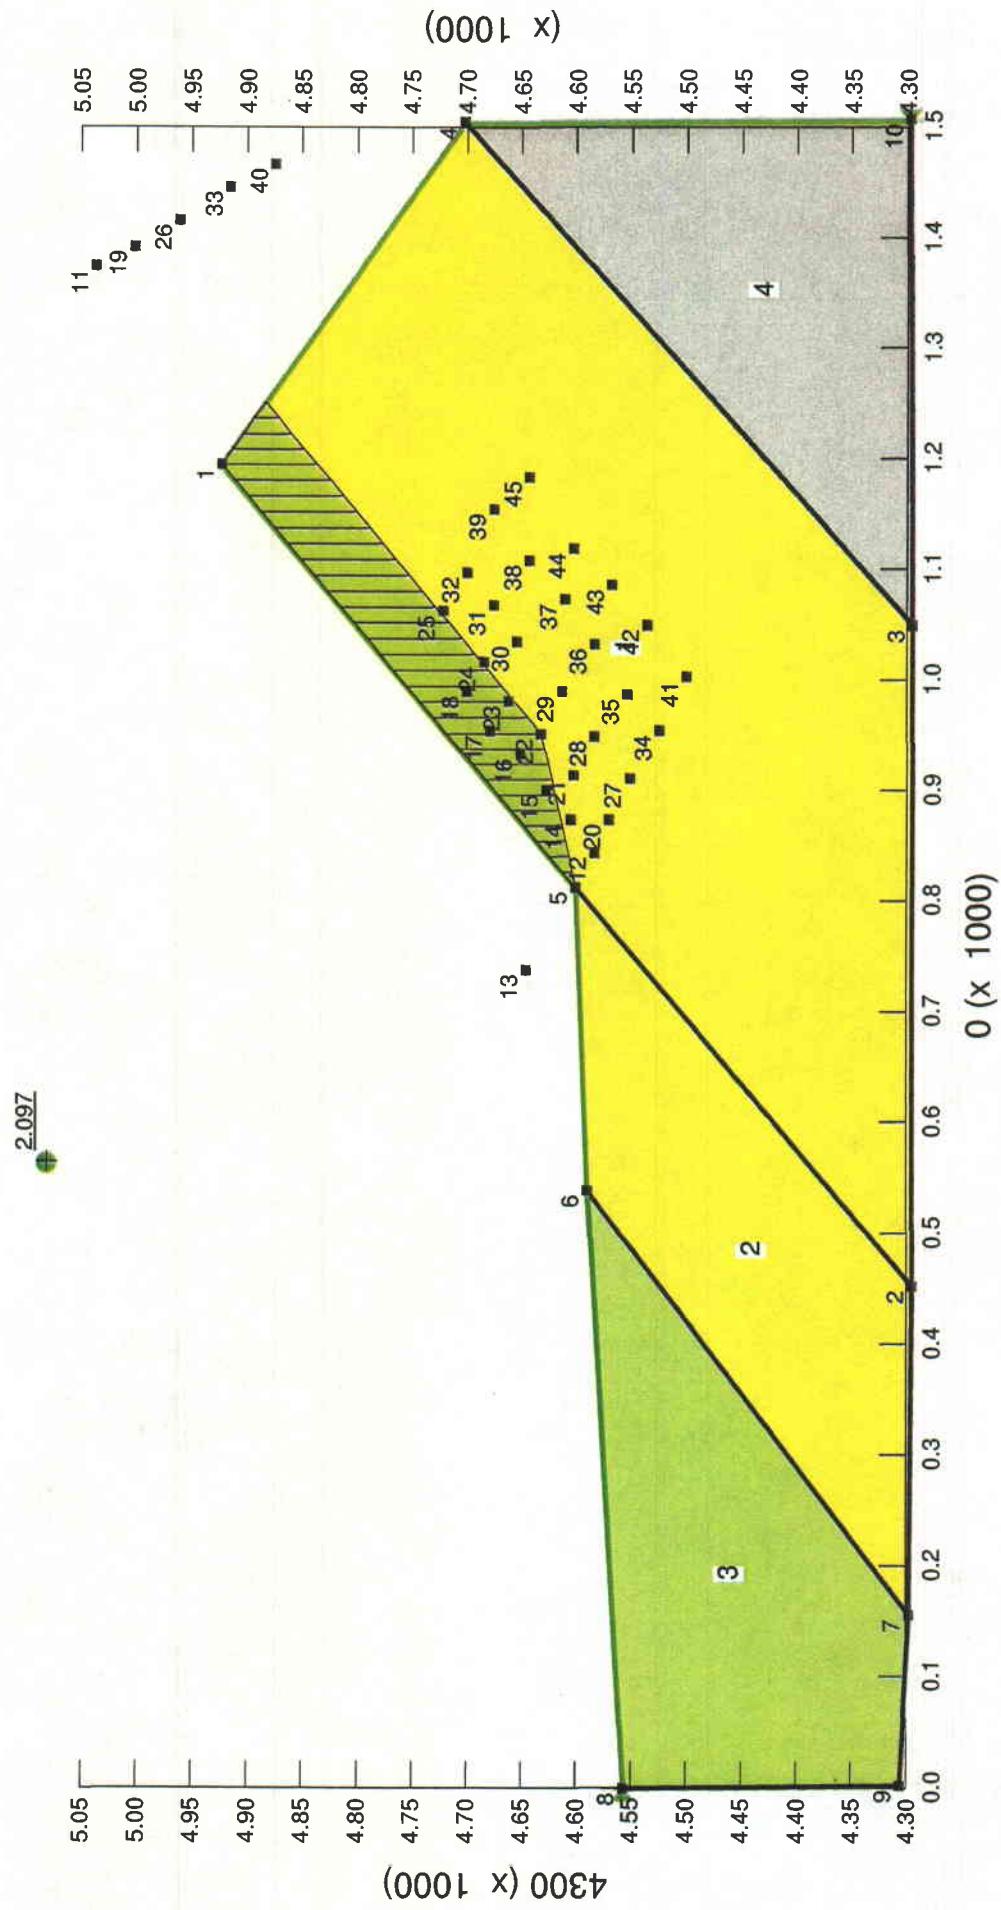
Name: 35 degrees.gsz

Material #: 1  
Description: Blast Disturbed Limestone  
Model: ShearNormalFn  
Wt: 100  
Strength Fn: 1  
Material #: 2  
Description: Undisturbed Limestone  
Model: ShearNormalFn  
Wt: 100  
Strength Fn: 2

Material #: 3  
Description: Alluvium  
Model: MohrCoulomb  
Wt: 100  
Cohesion: 0  
Phi: 45  
Material #: 4  
Description: Bedrock  
Model: Bedrock
